# Your Inspection Report

Friday, July 22, 2022

Paul Saban

Can Spec Inspection Services  
1550 Kingston Road, Suite 1354  
Pickering, ON L1V 6W9

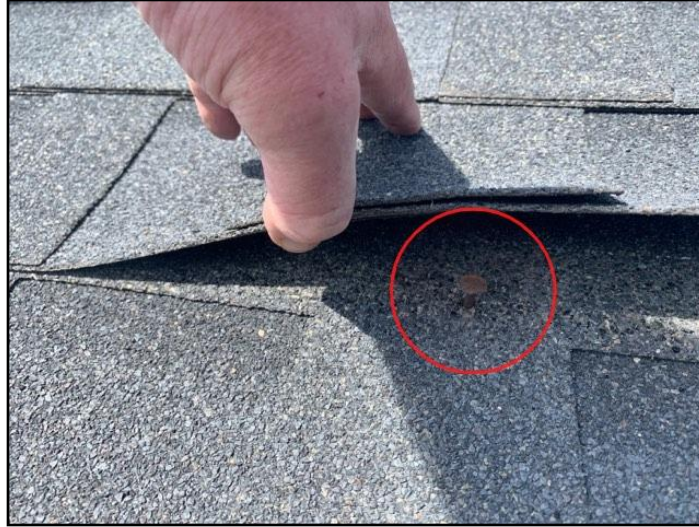
3. **Condition:** • [Missing, loose or torn](#)

**Implication(s):** Chance of water damage to structure, finishes and contents

**Location:** North

5. Missing, loose or torn

**Task:** Repair  
**Time:** Immediate  
**Cost:** Minor

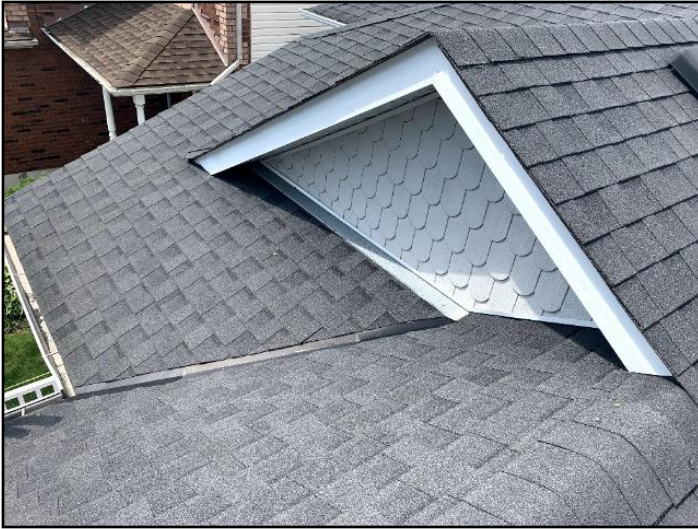
4. Condition: • [Doesn't widen at bottom](#)

Implication(s): Chance of water damage to structure, finishes and contents

6. Doesn't widen at bottom

Task: Improve

Time: As soon as practical

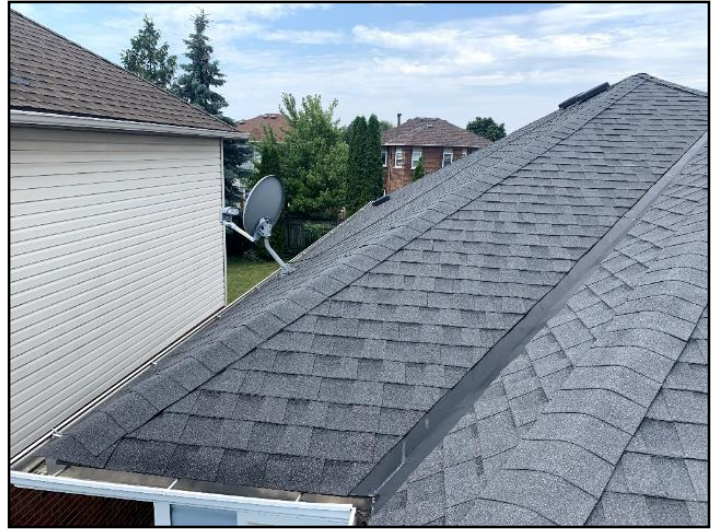
7. Doesn't widen at bottom

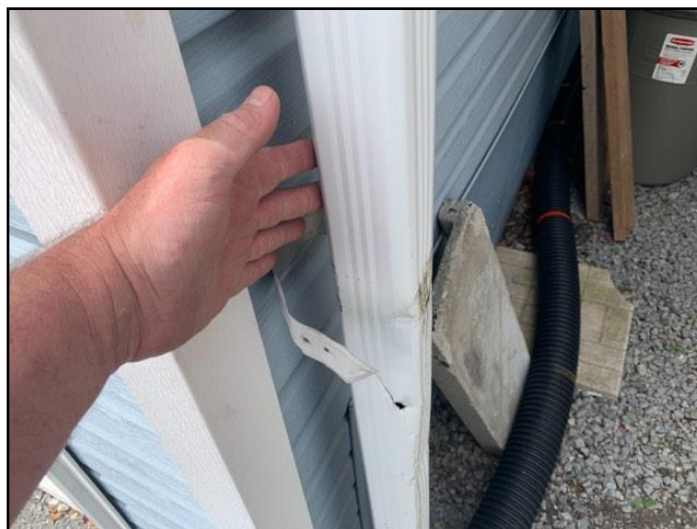
5. Condition: • [Connections loose](#)

Implication(s): Leakage

Location: Various

8. Connections loose

Task: Improve

Time: As soon as practical

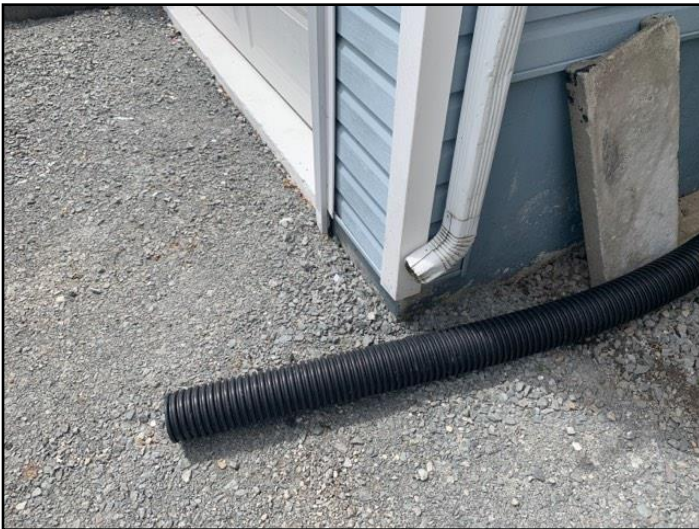
6. Condition: • [Should discharge 6 feet from building](#)

Implication(s): Chance of water damage to structure, finishes and contents

9. Should discharge 6 feet from building

Space to lead water away proper distance on your property will be a challenge due to neighbours proximity. If basement leakage detected, consult specialist on how to lead water away from foundation.

Task: Improve

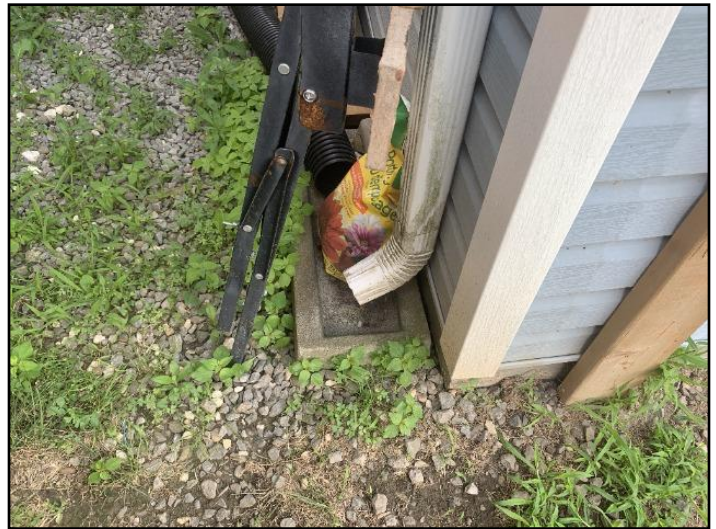
10. Should discharge 6 feet from building

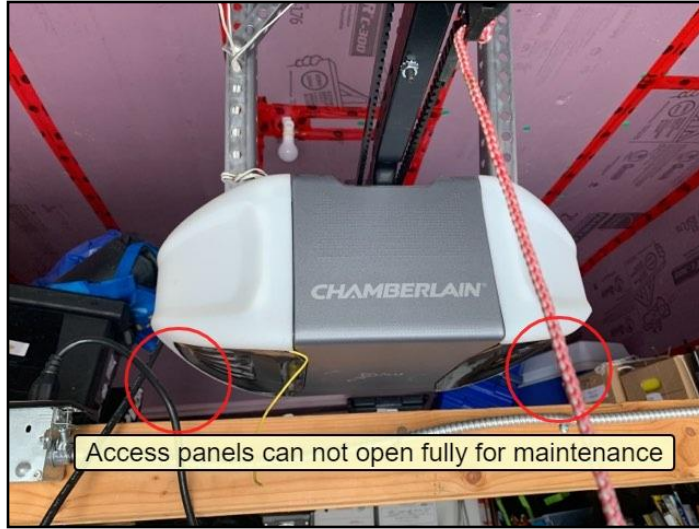
7. **Condition:** • Service access panels  
Shelving restricts full accessibility to service unit

11. Service access panels

**Task:** Improve

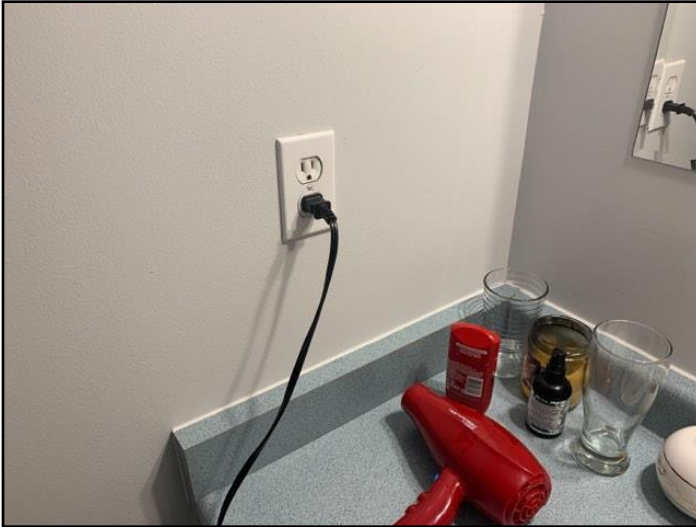
**9. Condition:** • Basement

**Location:** Basement Kitchen & Bathroom

12. GFCI - basement bathroom

Provide GFCI at noted locations.

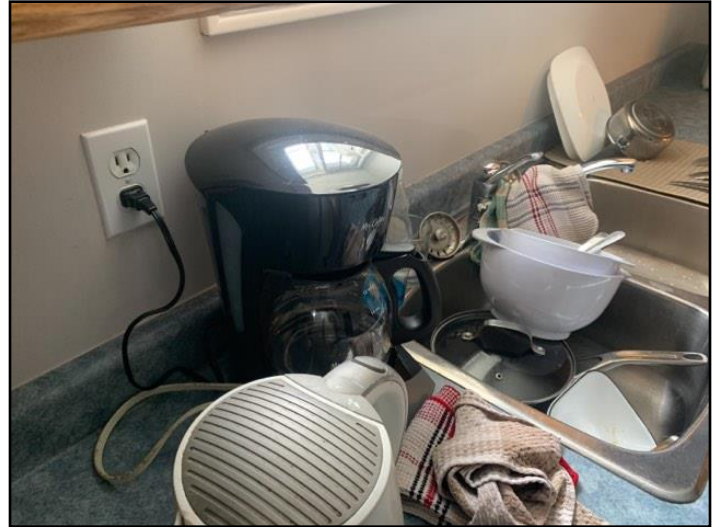
13. GFCI - basement kitchen

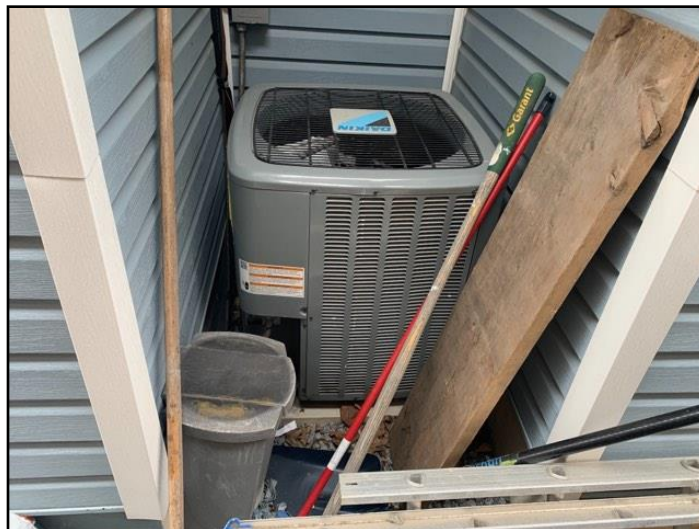
**11. Condition:** • Poor access

Airflow and access blocked by walls and debris/crowding.

**Implication(s):** Difficult to service

18. Poor access

Keep access to and around condenser unit as clear as possible to improve life expectancy. Consider relocating to reduce unit overheating. If not relocated, it could lead to premature end of life. If no plans to relocate at present, continue to operate and service until units end of life, then consult specialist re: appropriate location for new unit.

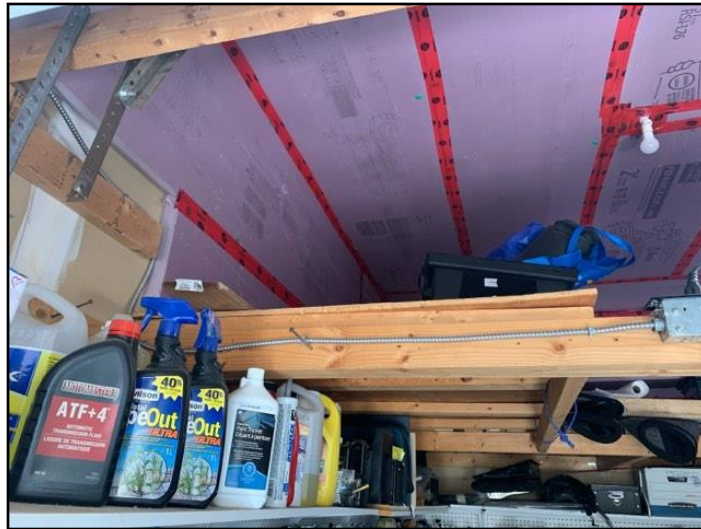
14. **Condition:** • [Exposed combustible insulation](#)

**Implication(s):** Increased fire hazard

**Location:** Garage

20. Not fireproof

Foam board insulation should be covered by approved material such as drywall or as per manufacturers label/recommendations.

**Task:** Correct

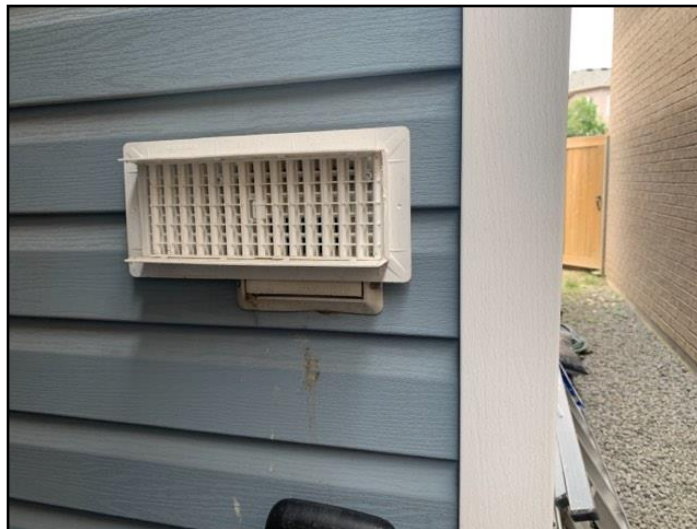
**19. Condition:** • [Inadequate air movement](#)

**Implication(s):** Chance of condensation damage to finishes and/or structure

**23.** *Inadequate air movement*

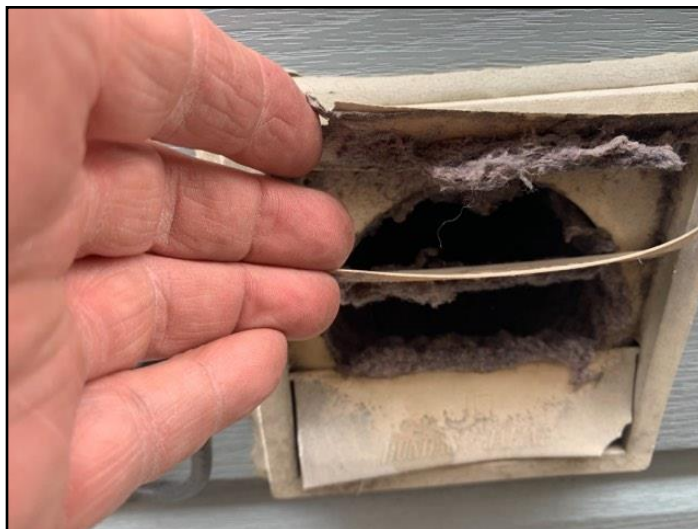
**22. Condition:** • Dryer vent obstructed

**Implication(s):** Equipment ineffective | Fire hazard

**24.** *Dryer vent obstructed*

Regular cleaning helps avoid build up. We also recommend a modern, vermin proof, exterior cap be installed as existing is not functioning as originally designed.

**Task:** Clean/Repair or replace
